DEBRIS/ICE/TPS ASSESSMENT  
AND  
PHOTOGRAPHIC ANALYSIS  
OF  
SHUTTLE MISSION STS-32R

January 9, 1990

Gregory N. Katnik  
NASA/Kennedy Space Center  
TV-MSD-22

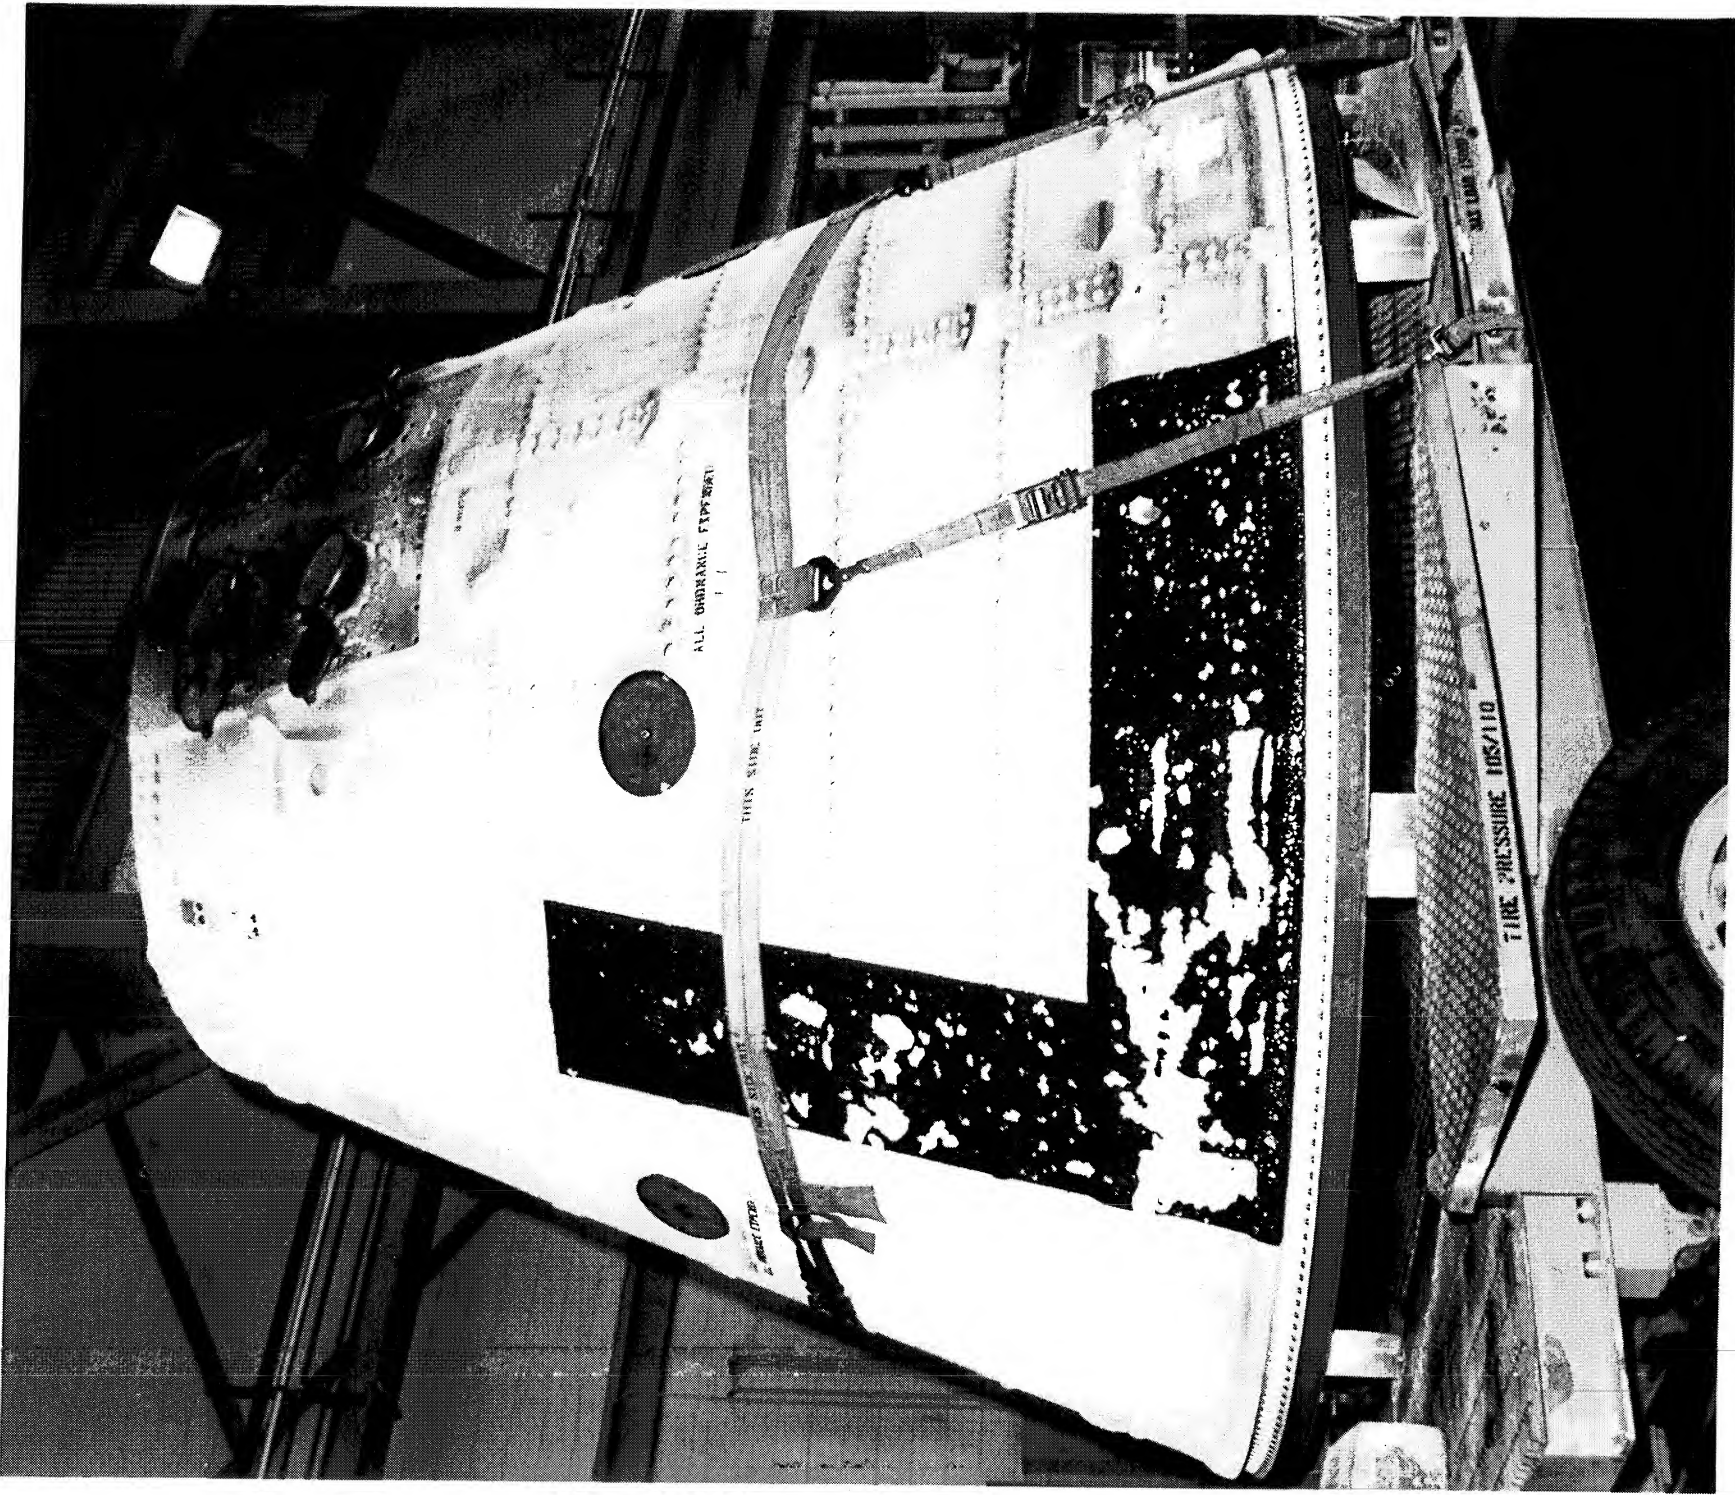
Overall view of RH frustum. Black Hypalon paint in visibility stripe has blistered and peeled away.

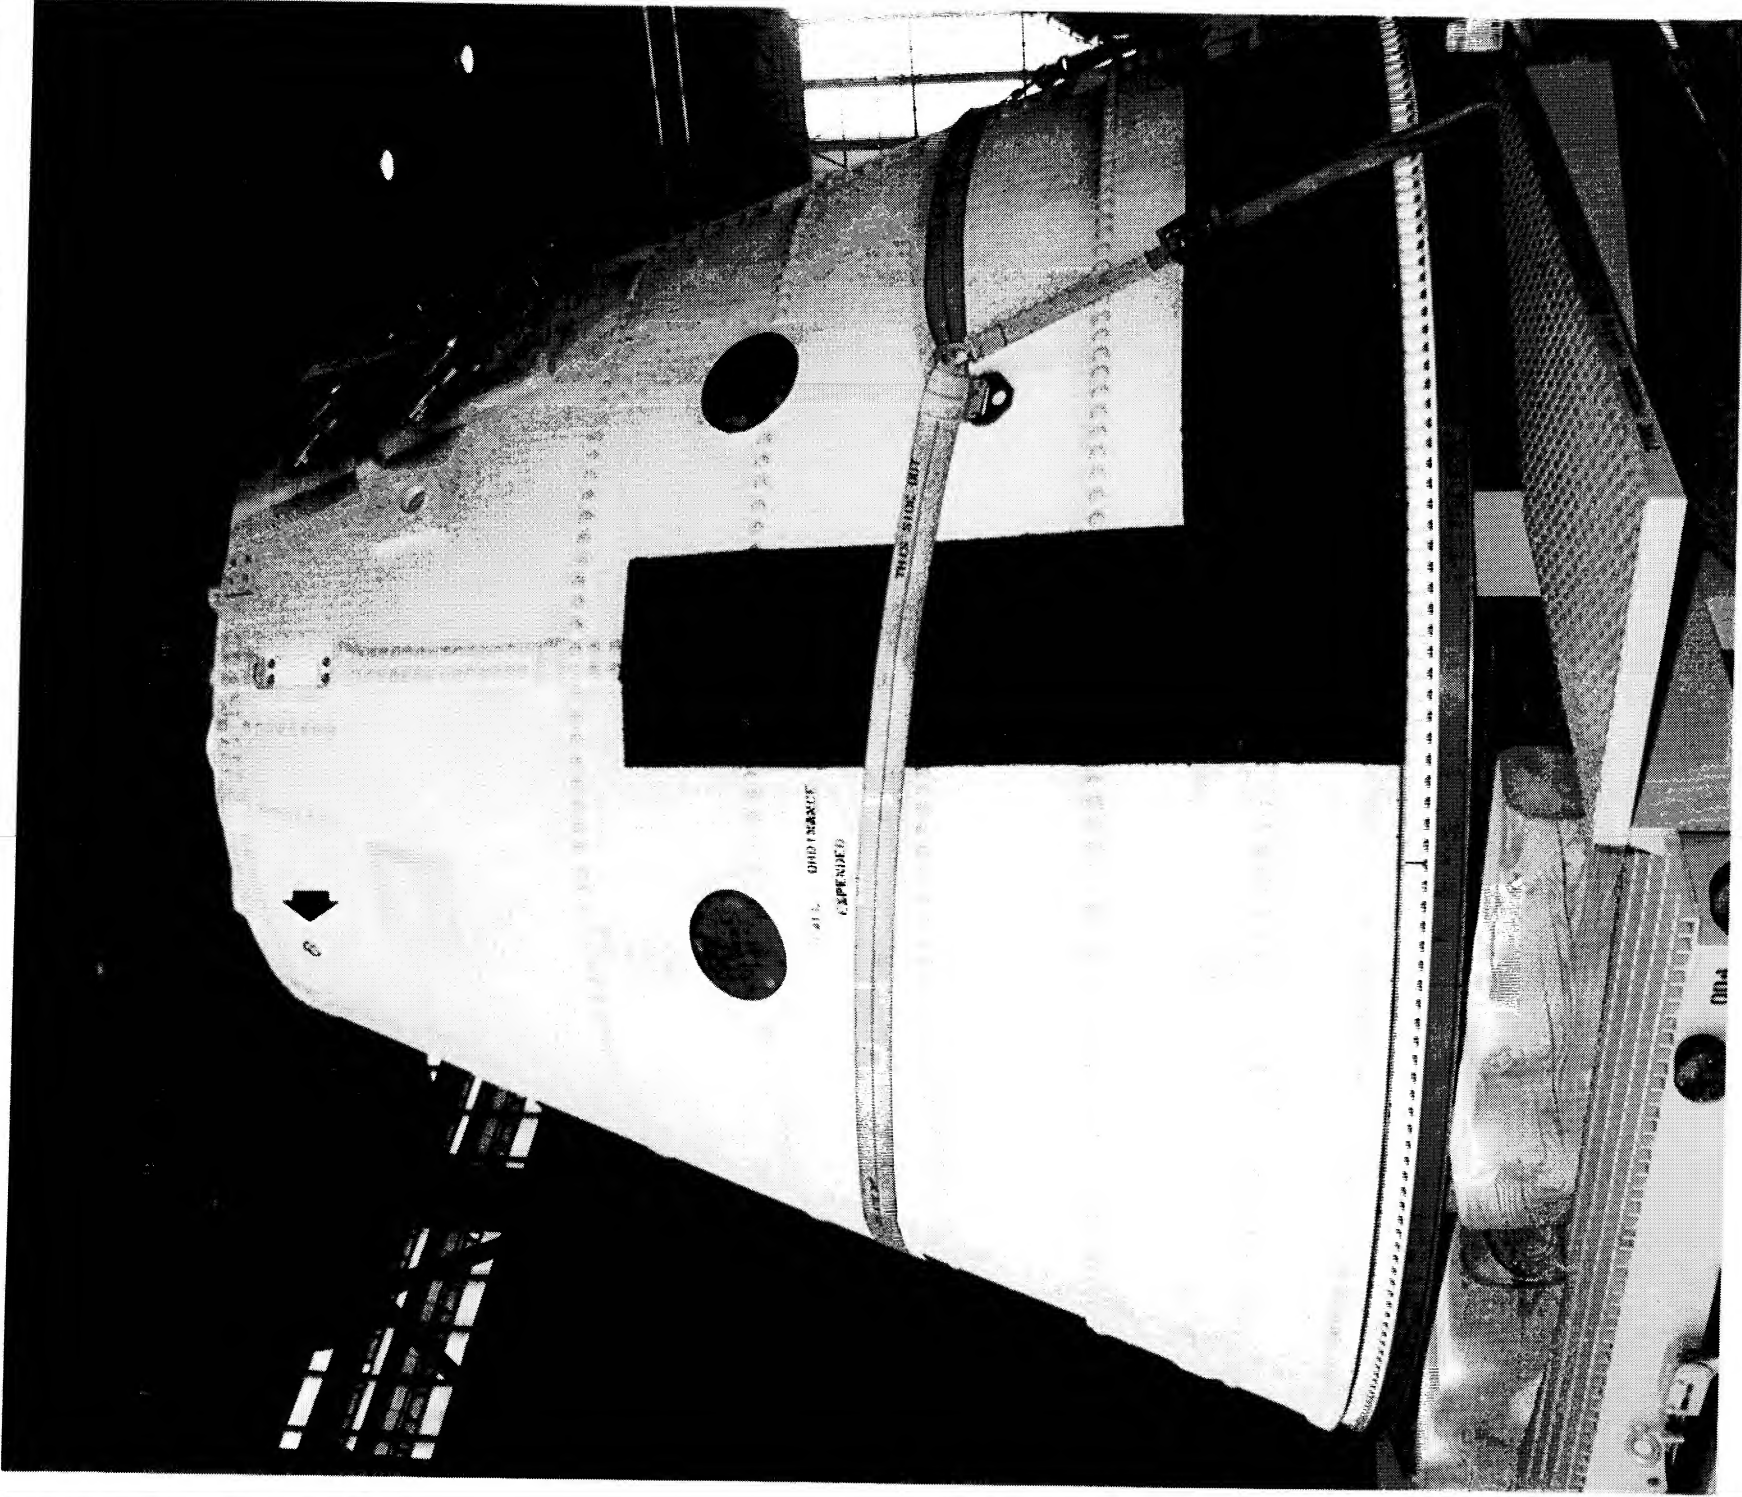
Overall view of LH frustum. A two inch diameter piece of MSA is missing from an area near the 275 ring.

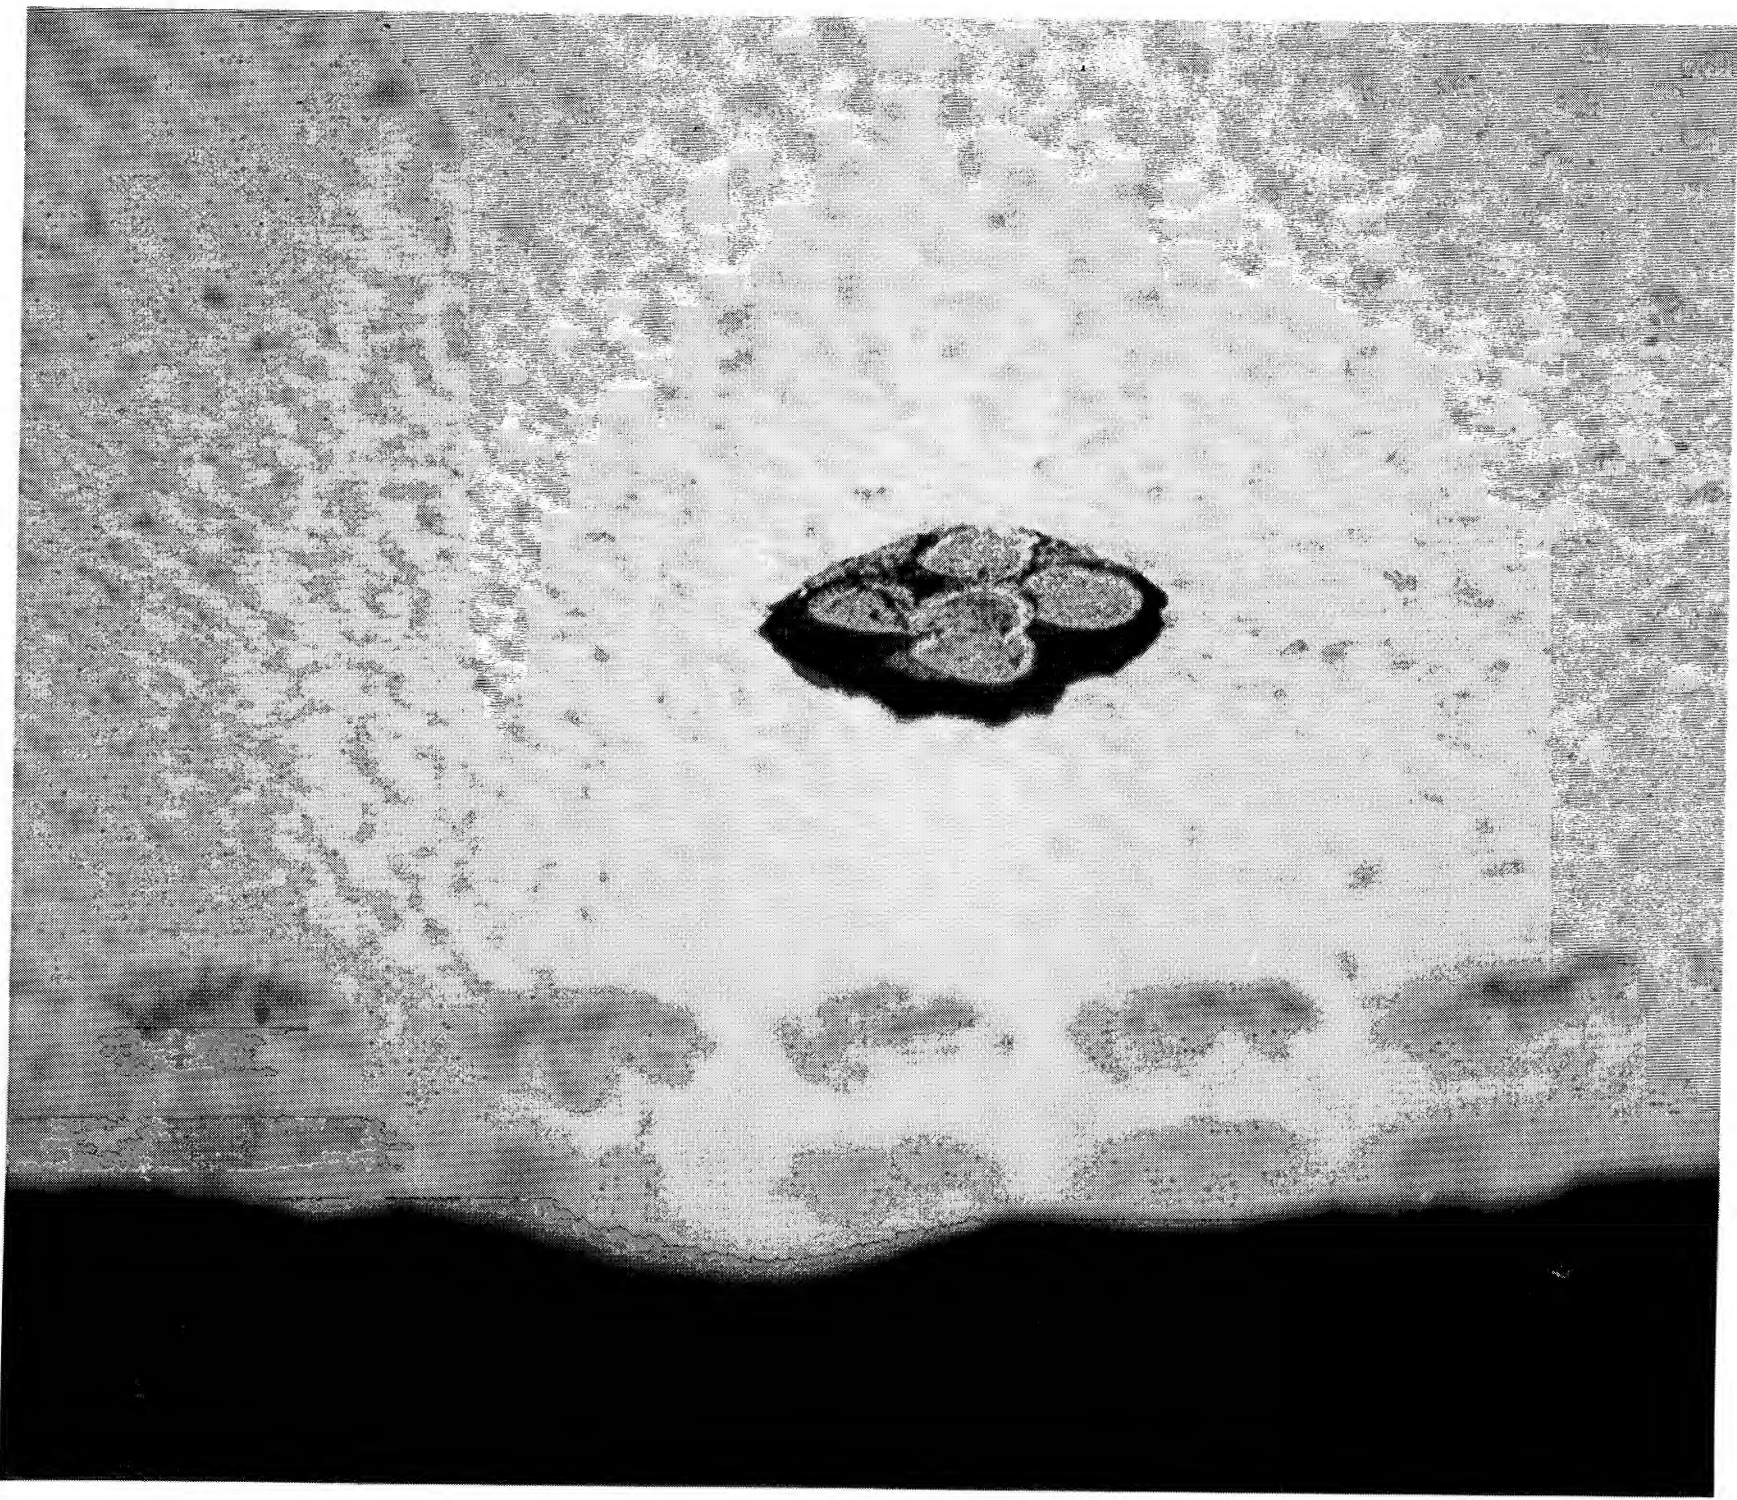
Close-in view of missing MSA near the 275 ring frame

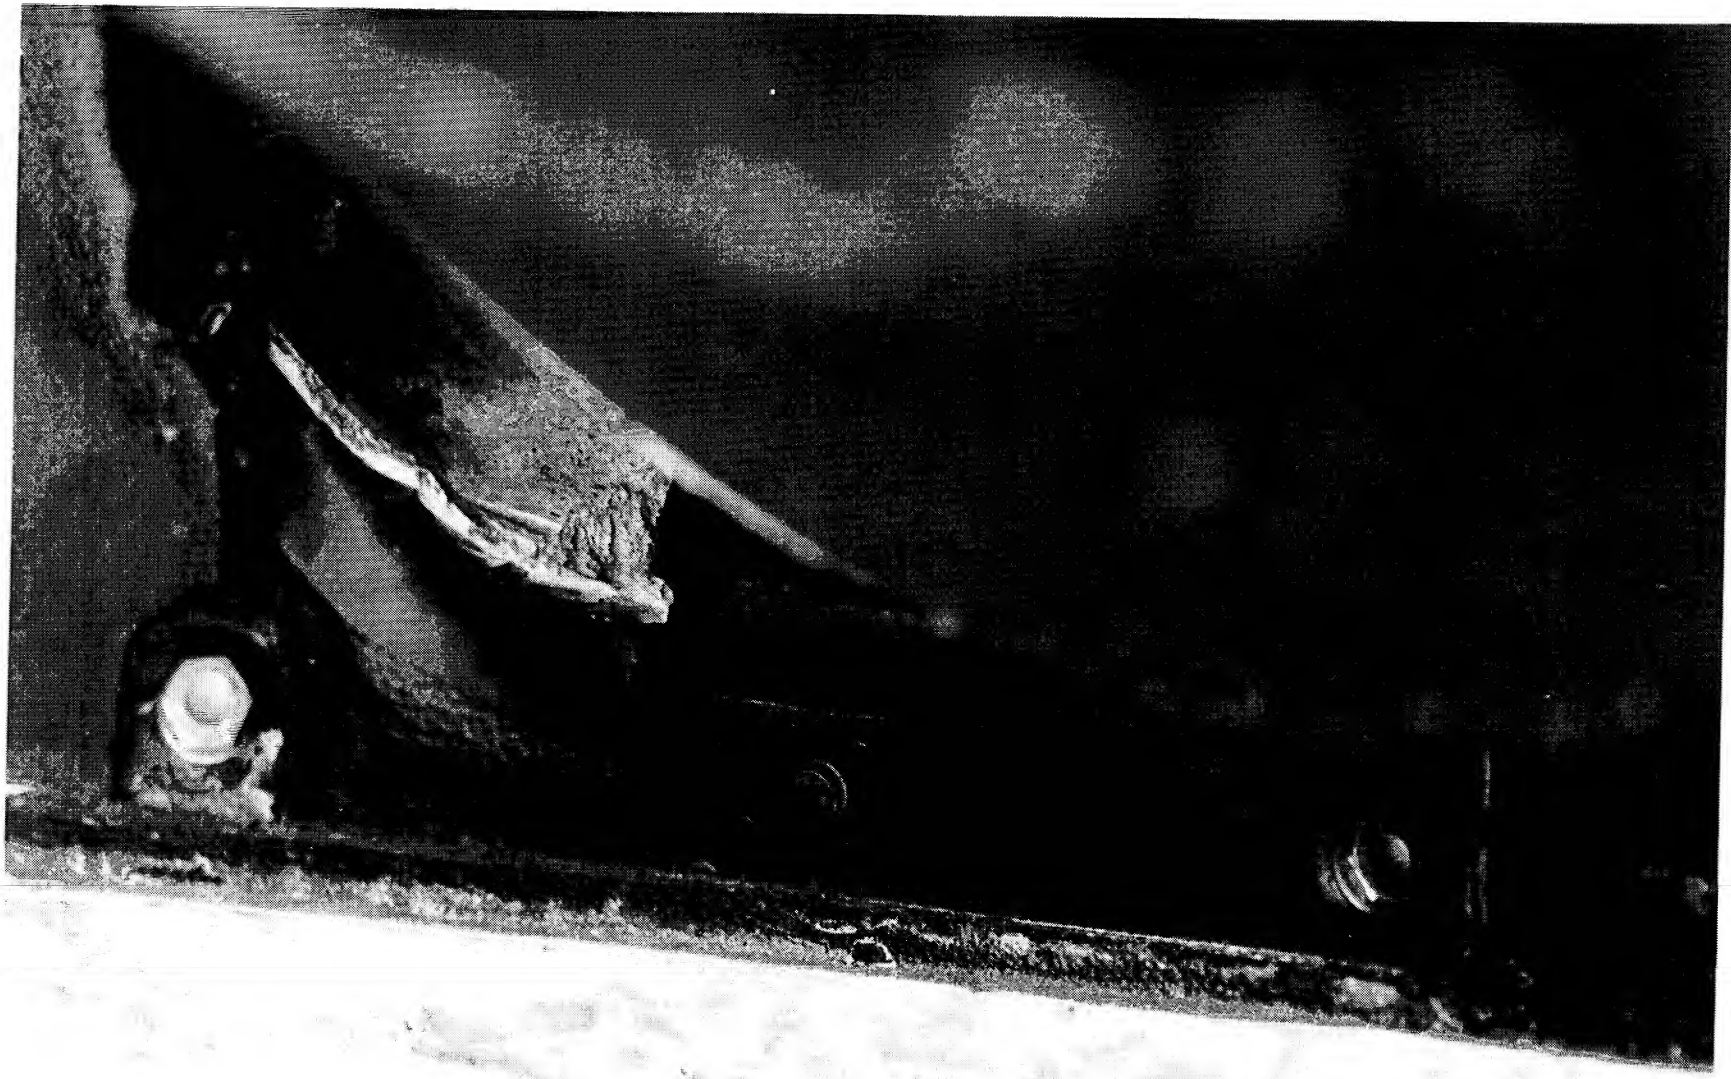
Missing bolt head and torn/missing EPDM cover at RH  
upper strut

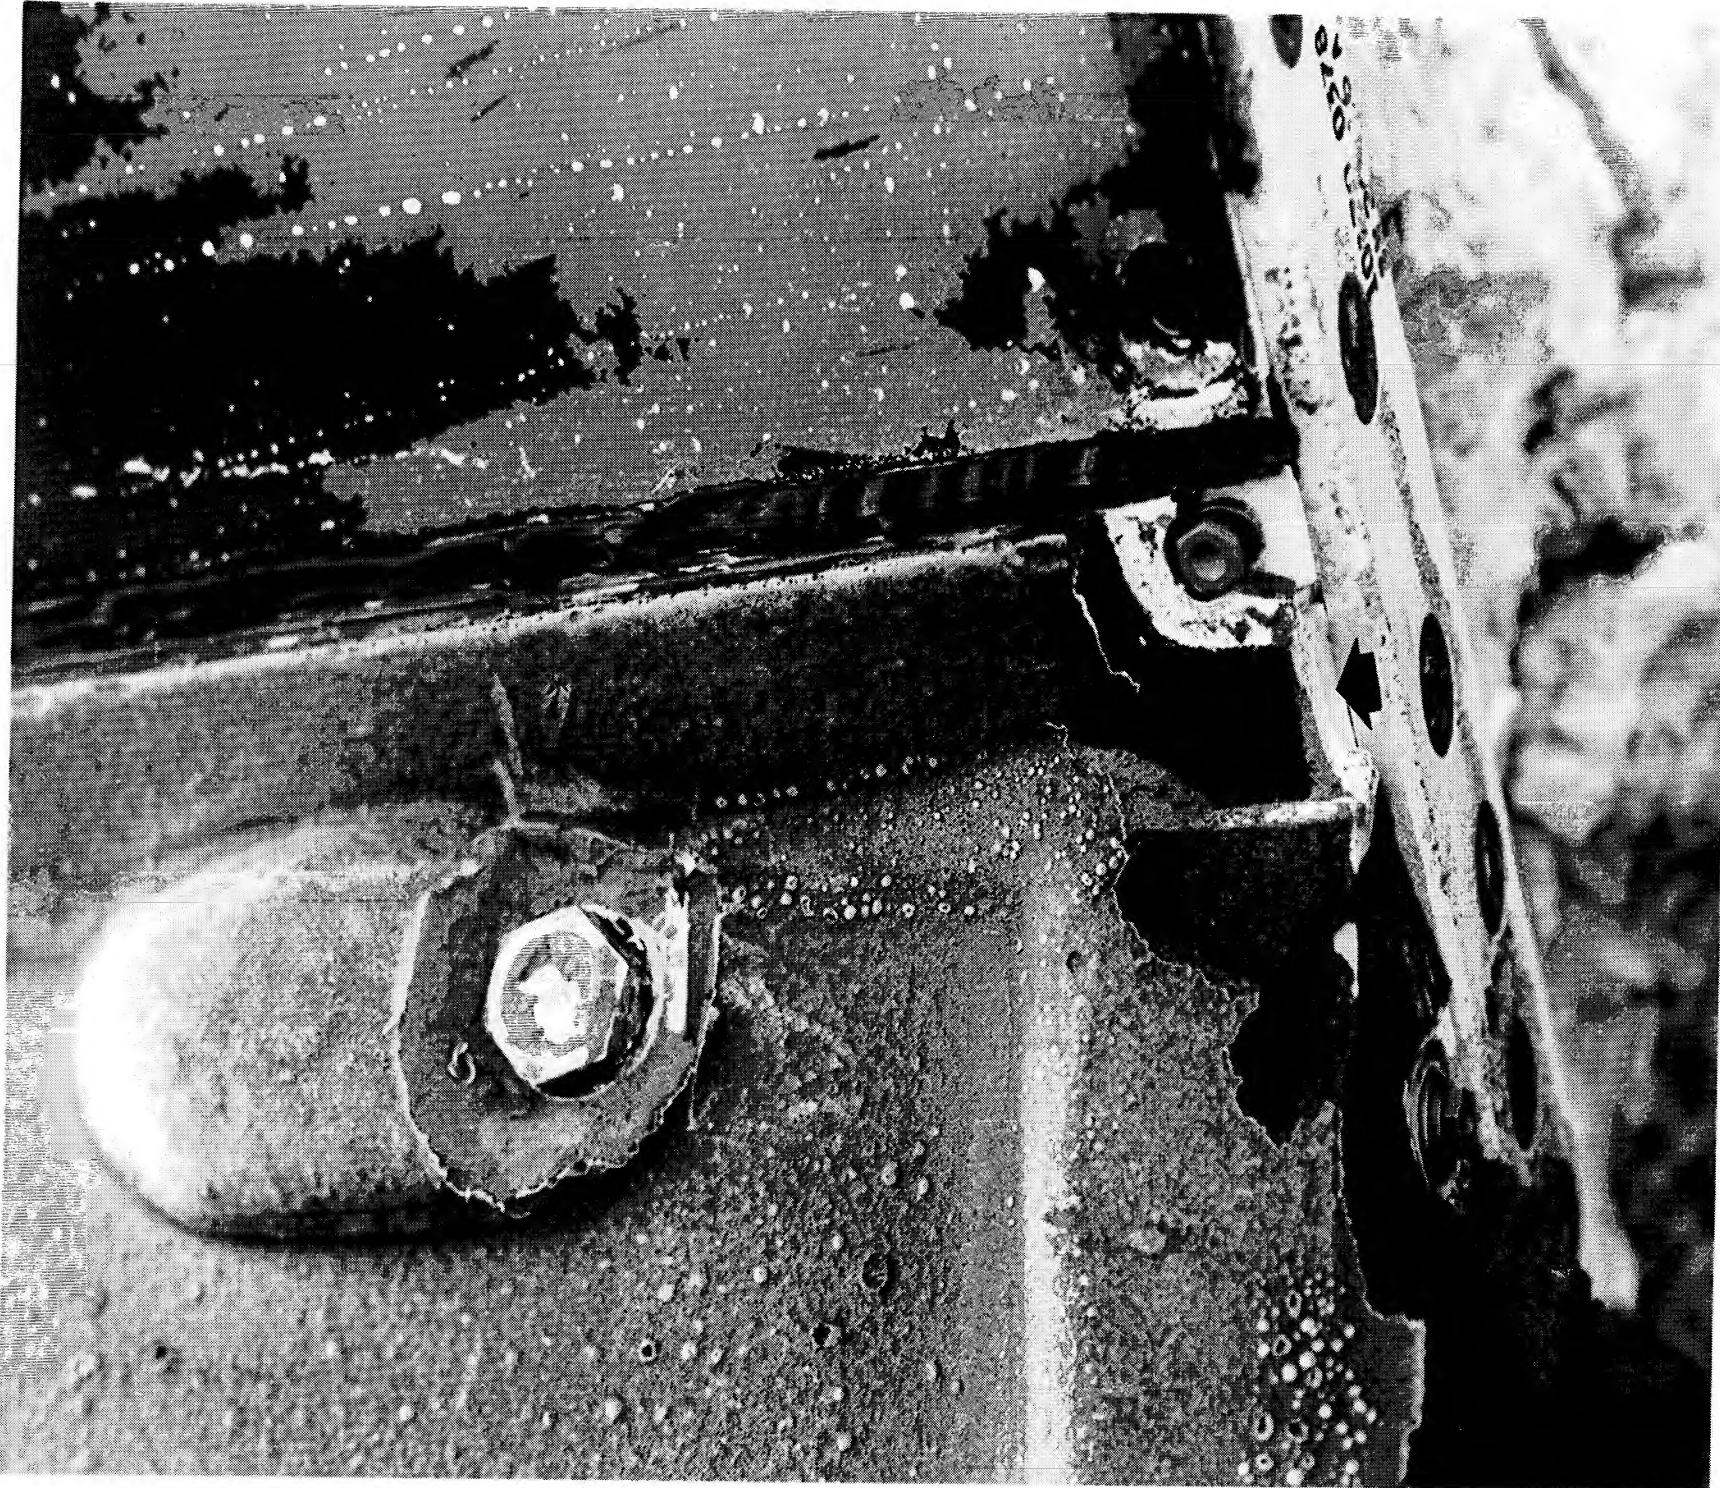
Missing ablator and broken/missing corner to RH ETA cover

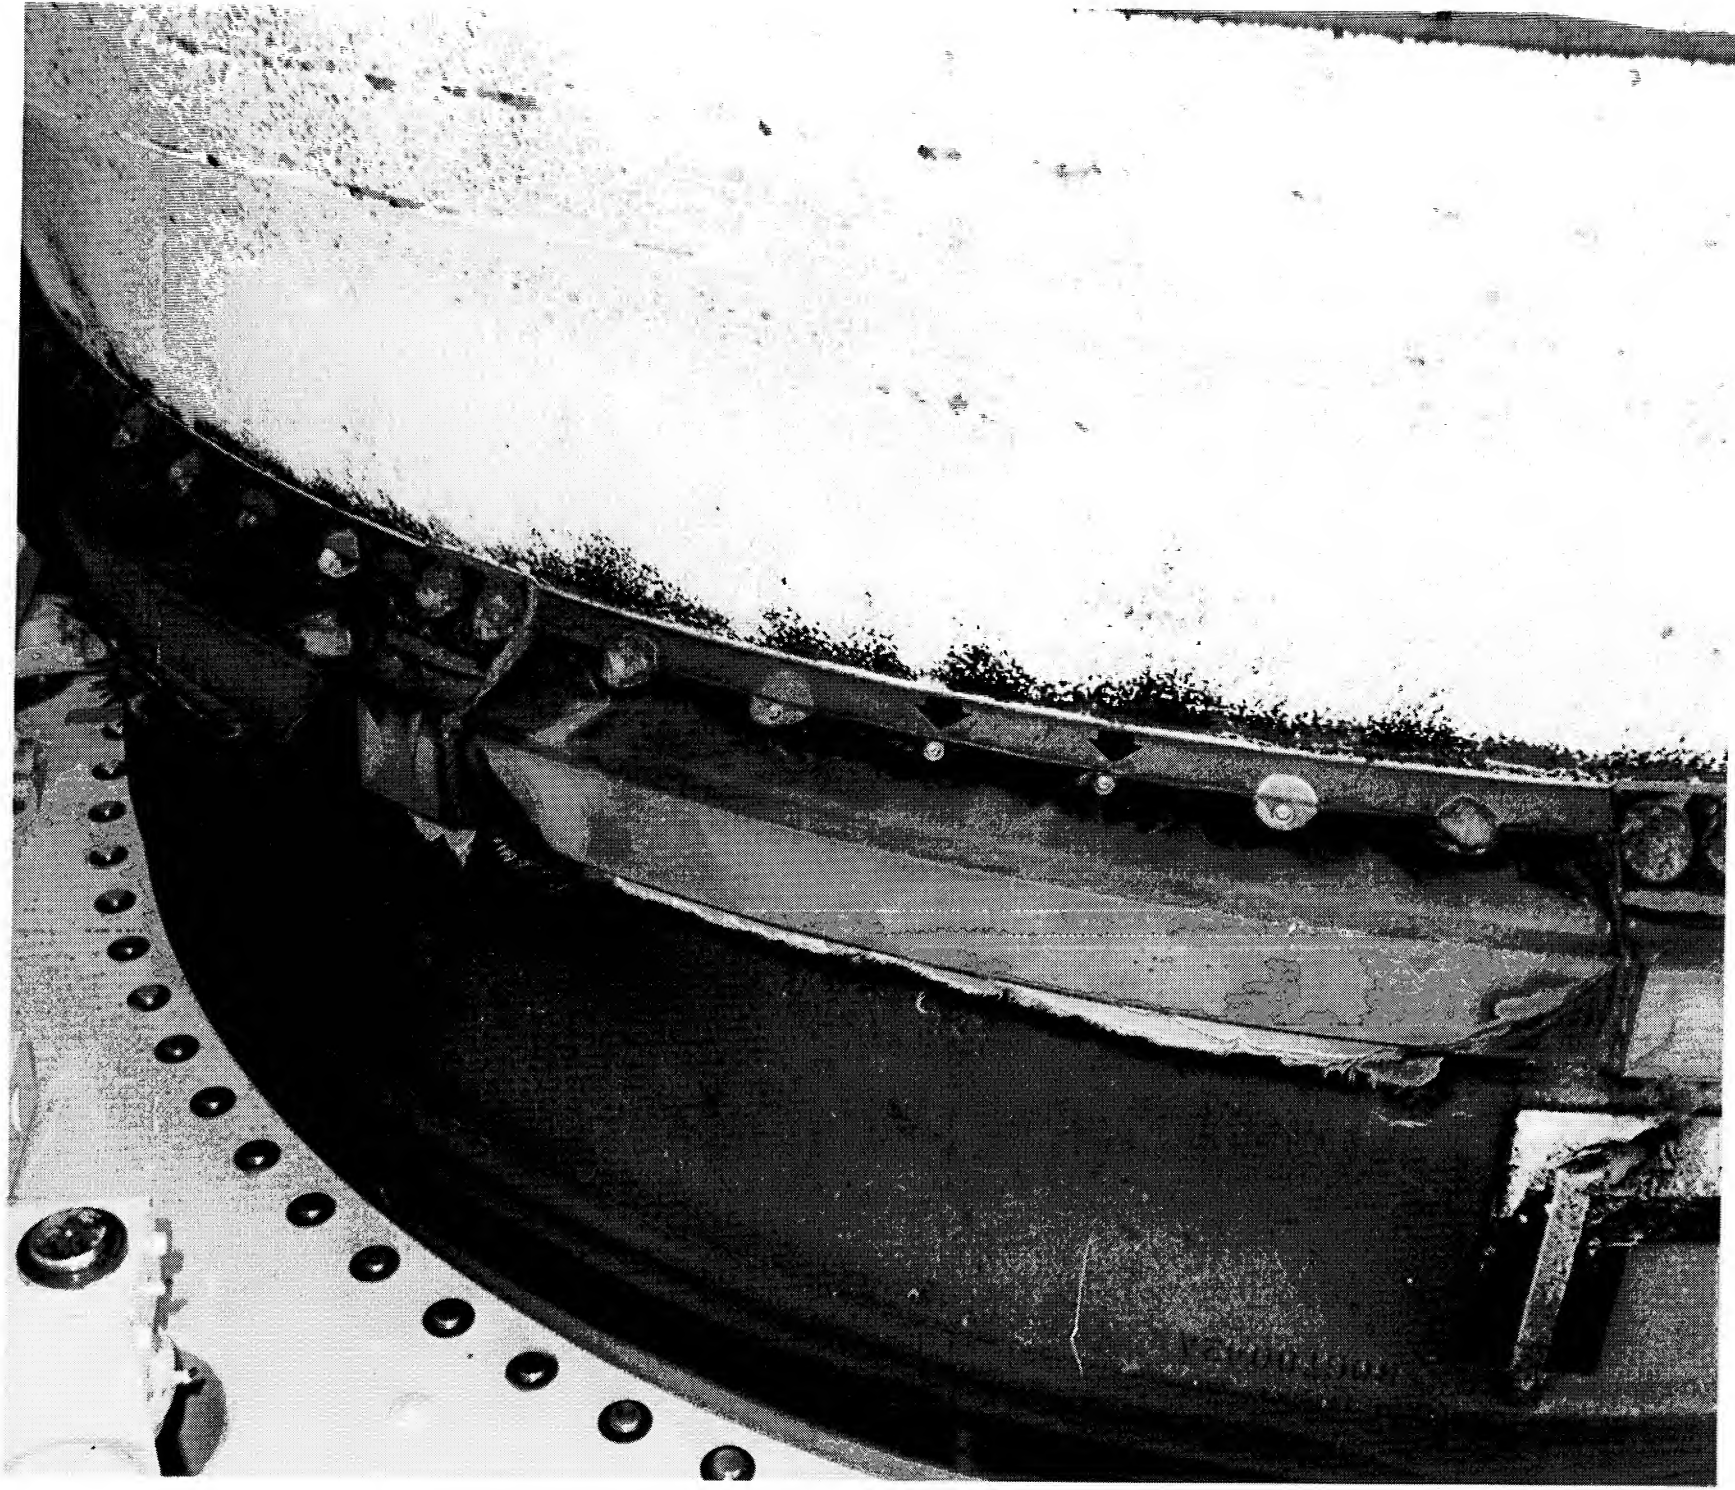
Phenolic delamination on aft kick ring. Note missing bolt head K5NA protective domes (arrows).

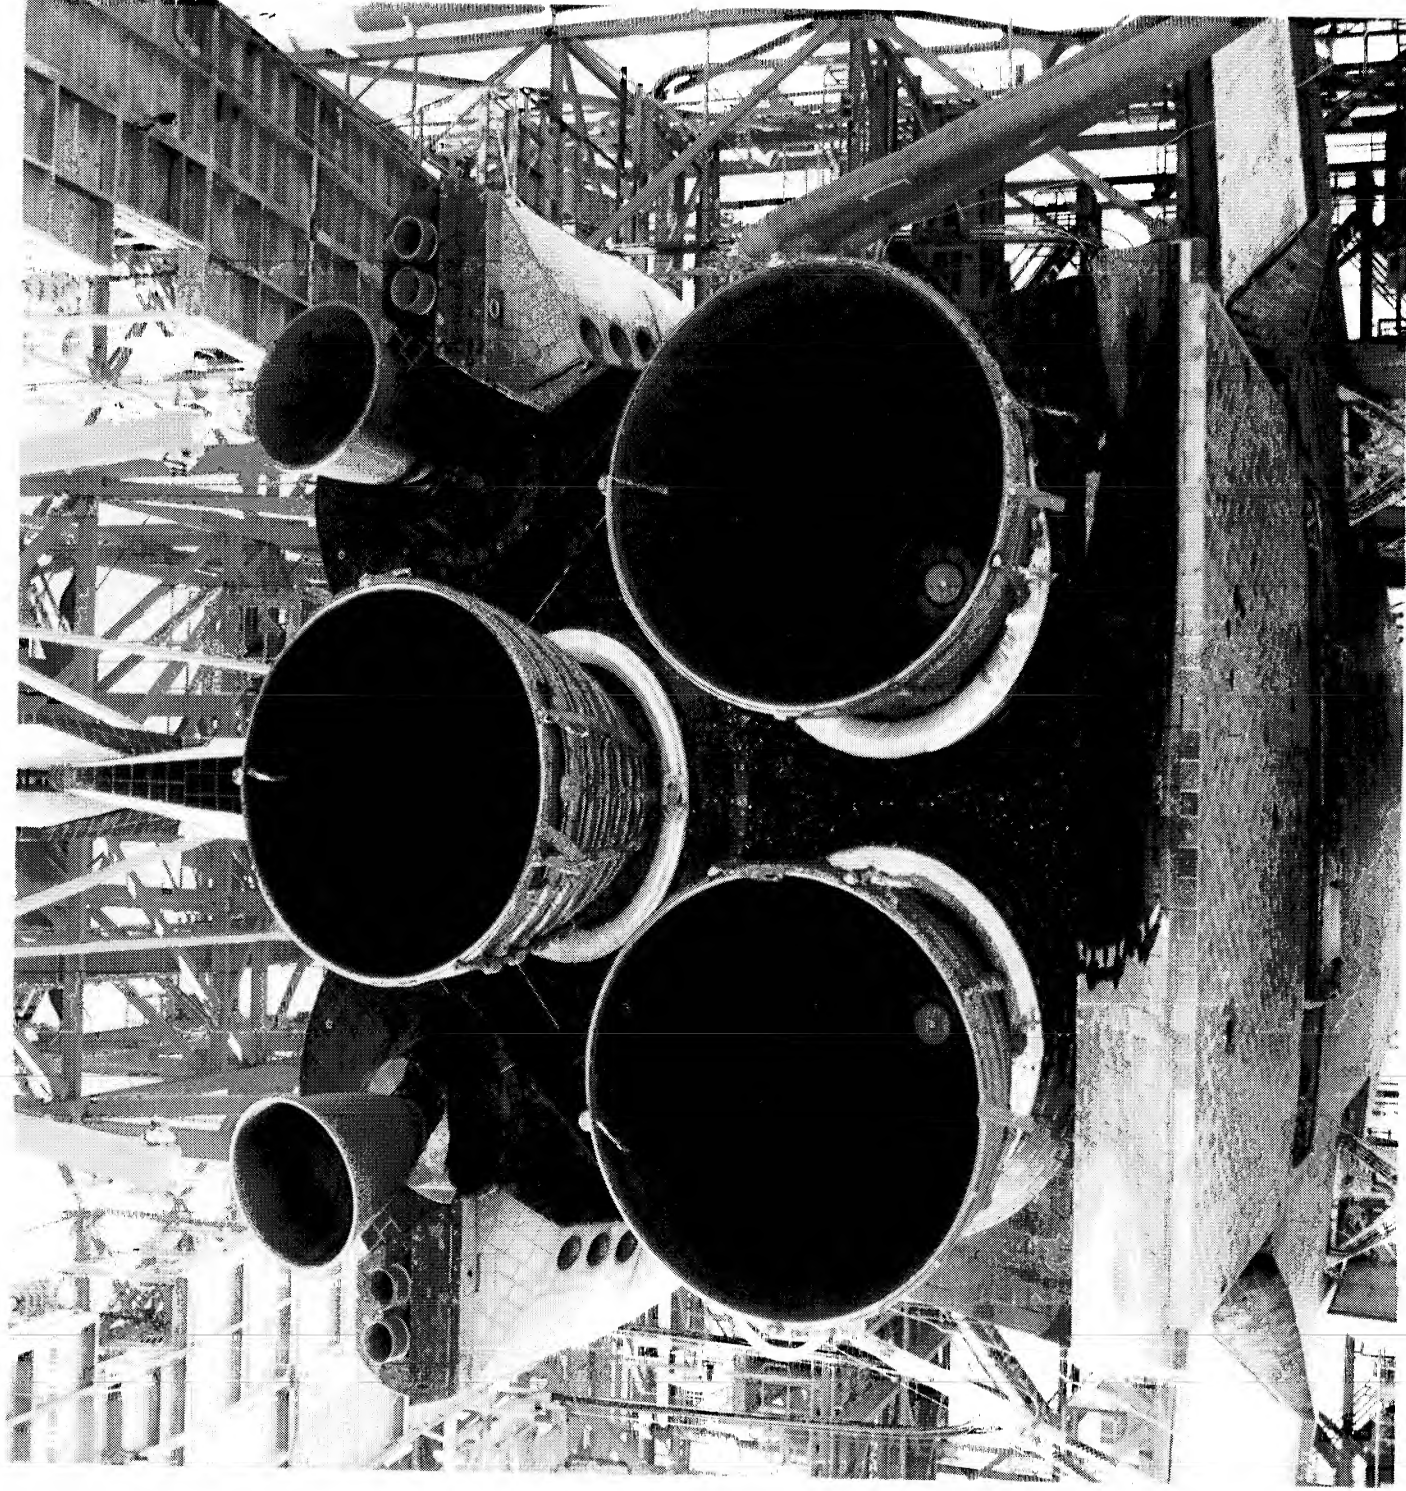
Overall view of SSME's and base heat shield. Note thermal blanket damage below SSME #1.

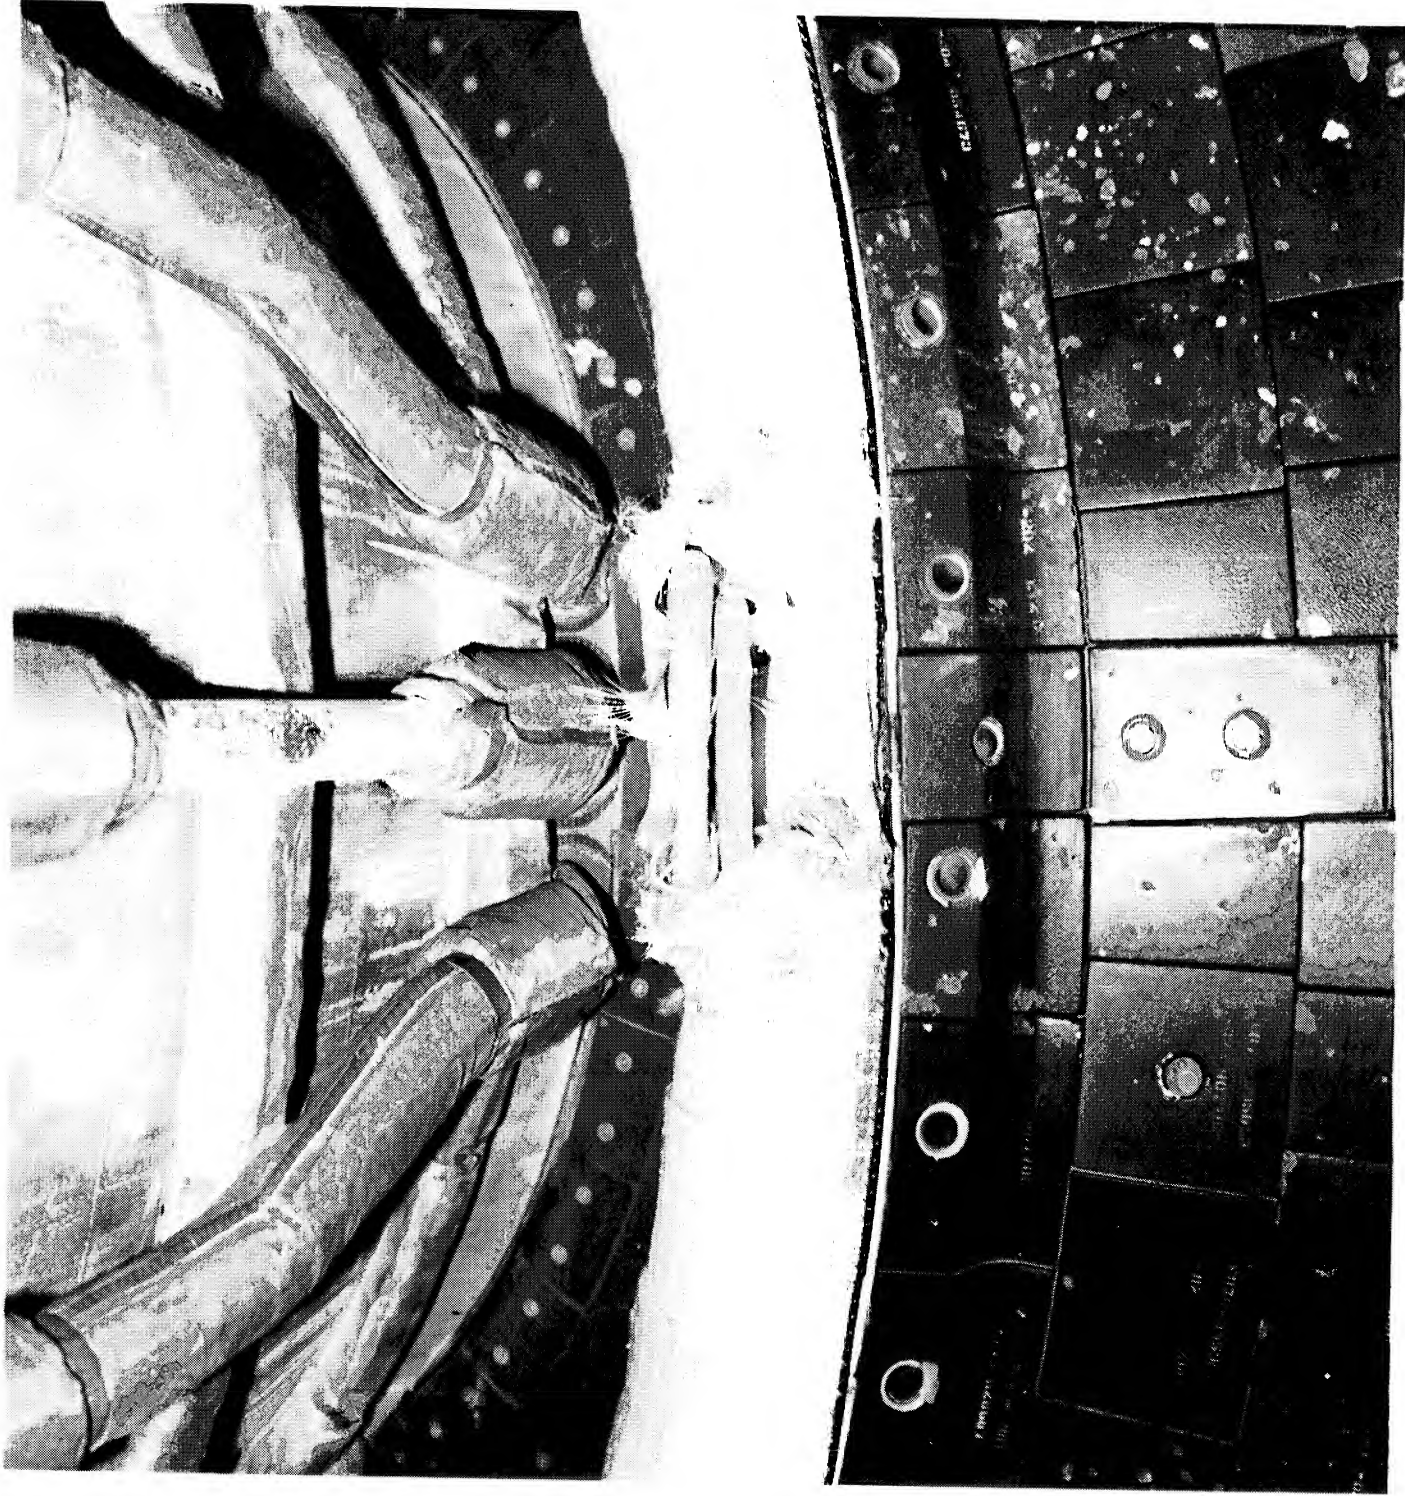
Close-in view of thermal (beta) blanket damage at 6 o'clock  
position on SSME #1

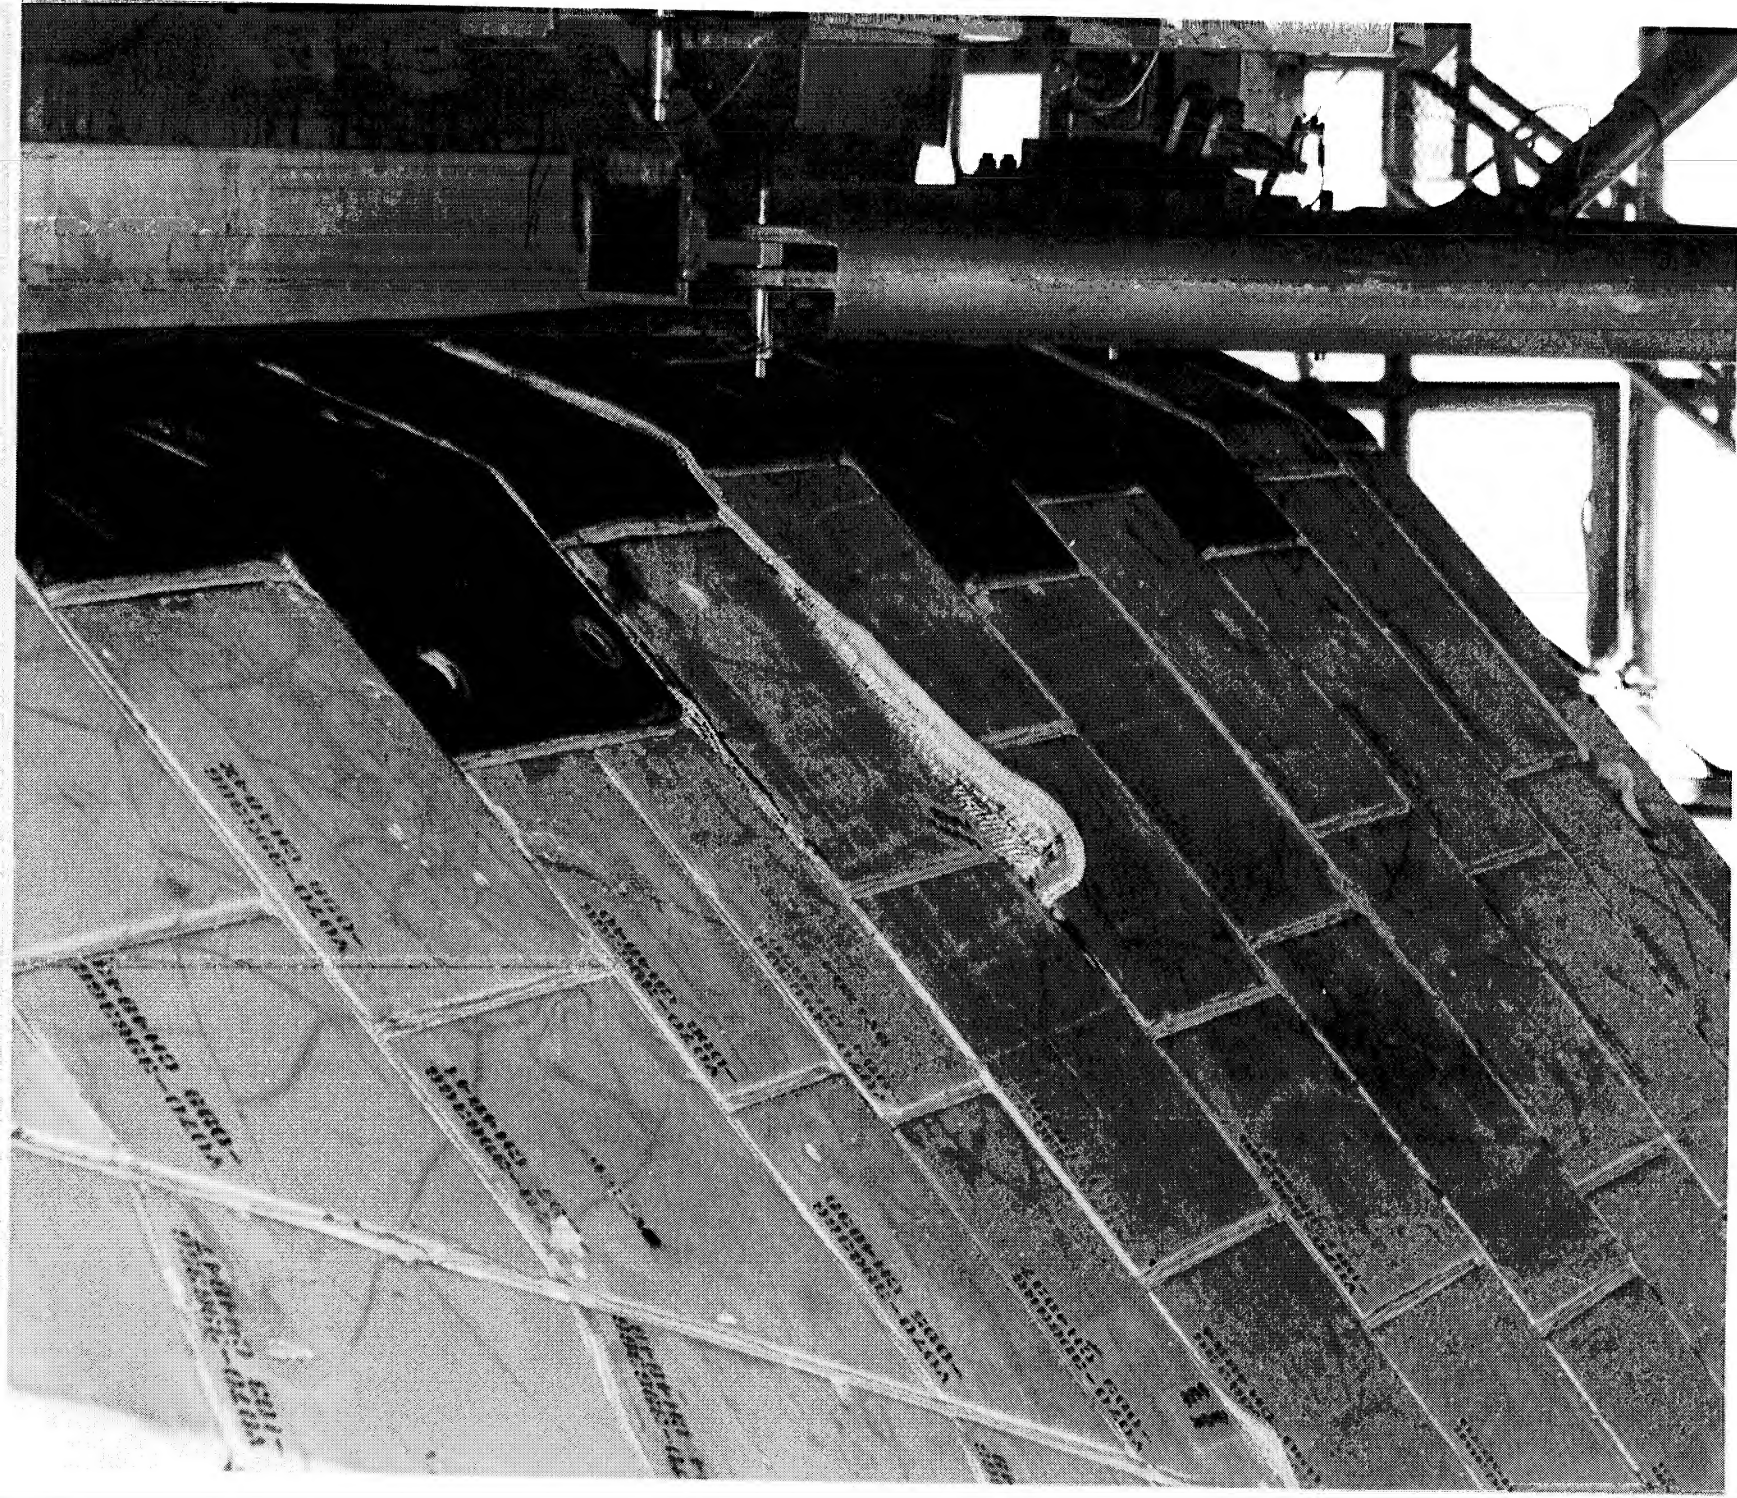
Gap filler protrudes from the LH OMS pod tiles. No damage to adjacent tiles surface coating material occurred.
